# City of Greeley Jackson Field Neighborhood Study February 2006

The Jackson Field Neighborhood Study has been identified as part of the Neighborhood Building Blocks (NB2) program. The NB2 team has identified that area conditions, feedback, and/or requests for assistance from residents indicate a number of issues that need better identification, coordinated response and a strategic plan to address. All maps and documentation can be found on the CD that accompanies this study.

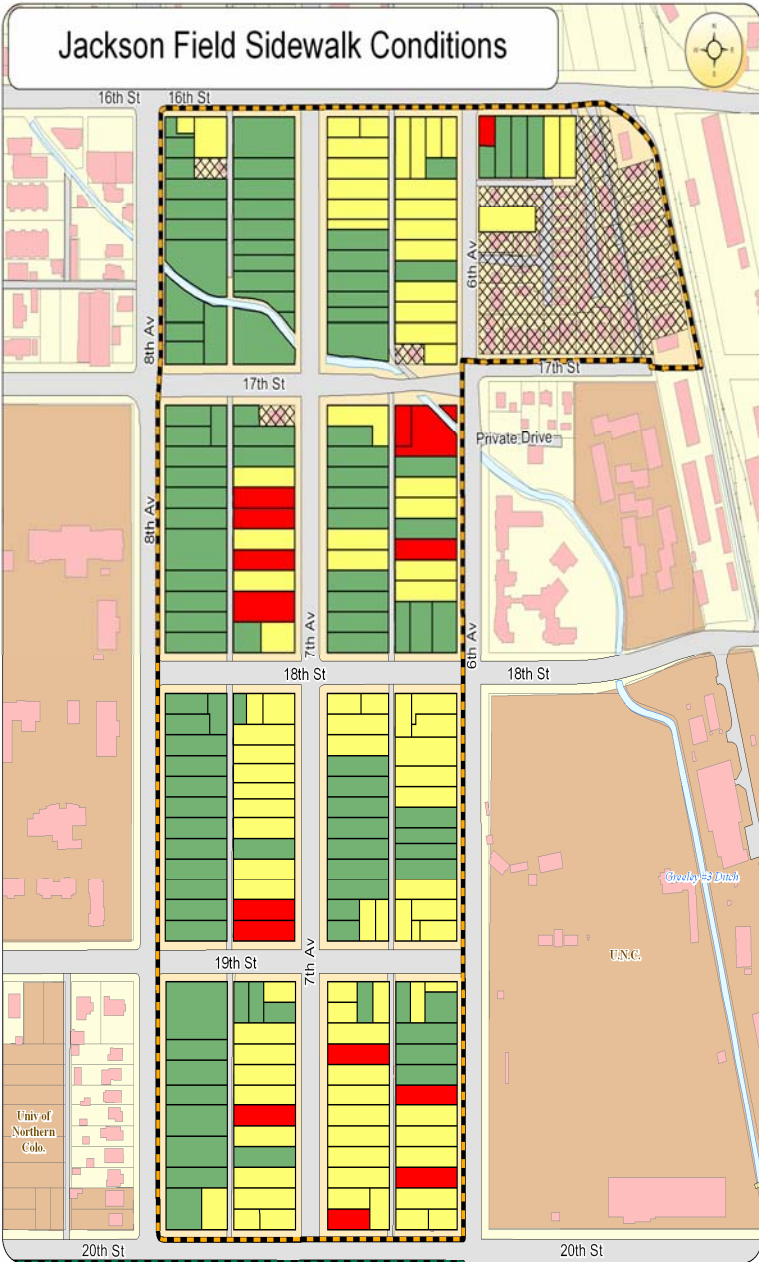
The sidewalks in the Jackson Field Neighborhood have areas with significant cracked and damaged concrete. The cost for installation and repair is as follows:

<u>Proposed Sidewalks</u>	<u>Cost/ Linear Foot</u>	<u>Total Cost</u>
250' (Missing)	\$20.00	\$5,000
1,409' (Inadequate)	\$20.00	\$28,180
		\$33,180

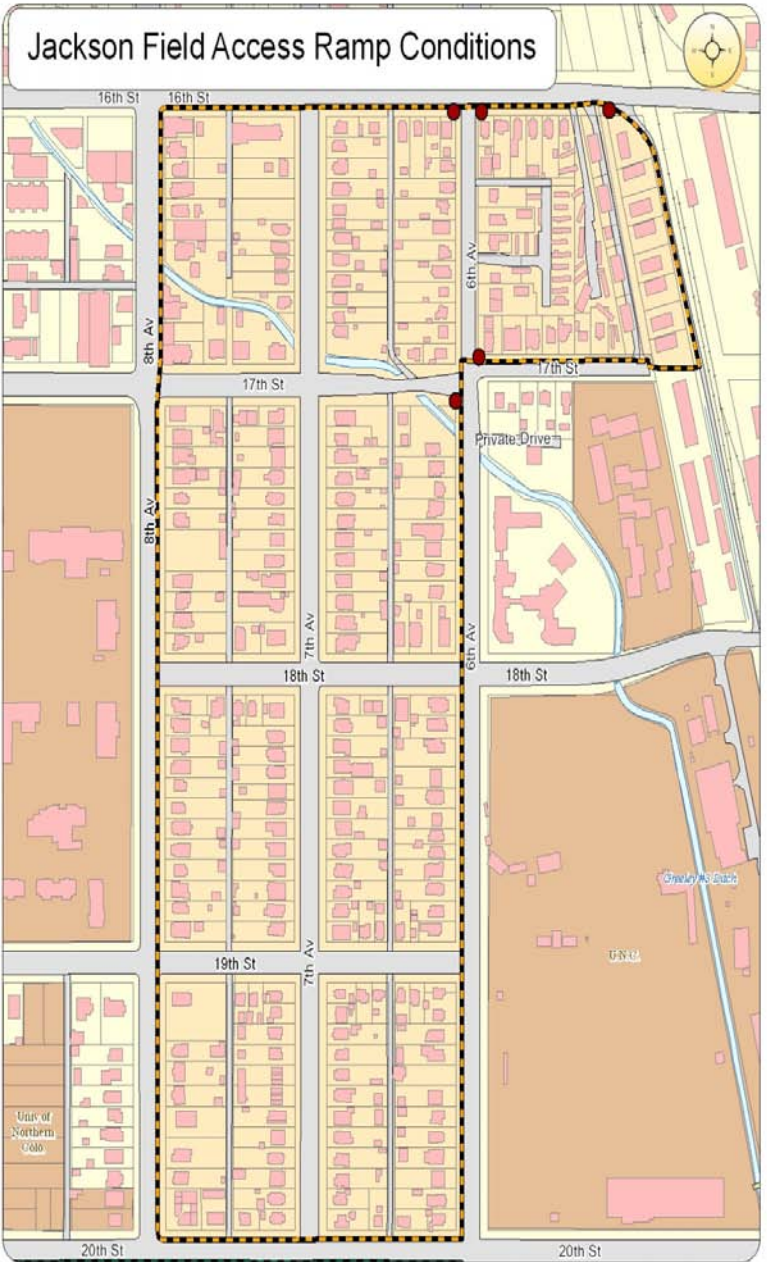
Missing access ramps have been identified and mapped as a part of this study. The installation cost of new ramps is as follows:

<u>Proposed Access Ramps</u>	<u>Cost/Ramp</u>	<u>Total Cost</u>
5	\$2,000	\$10,000

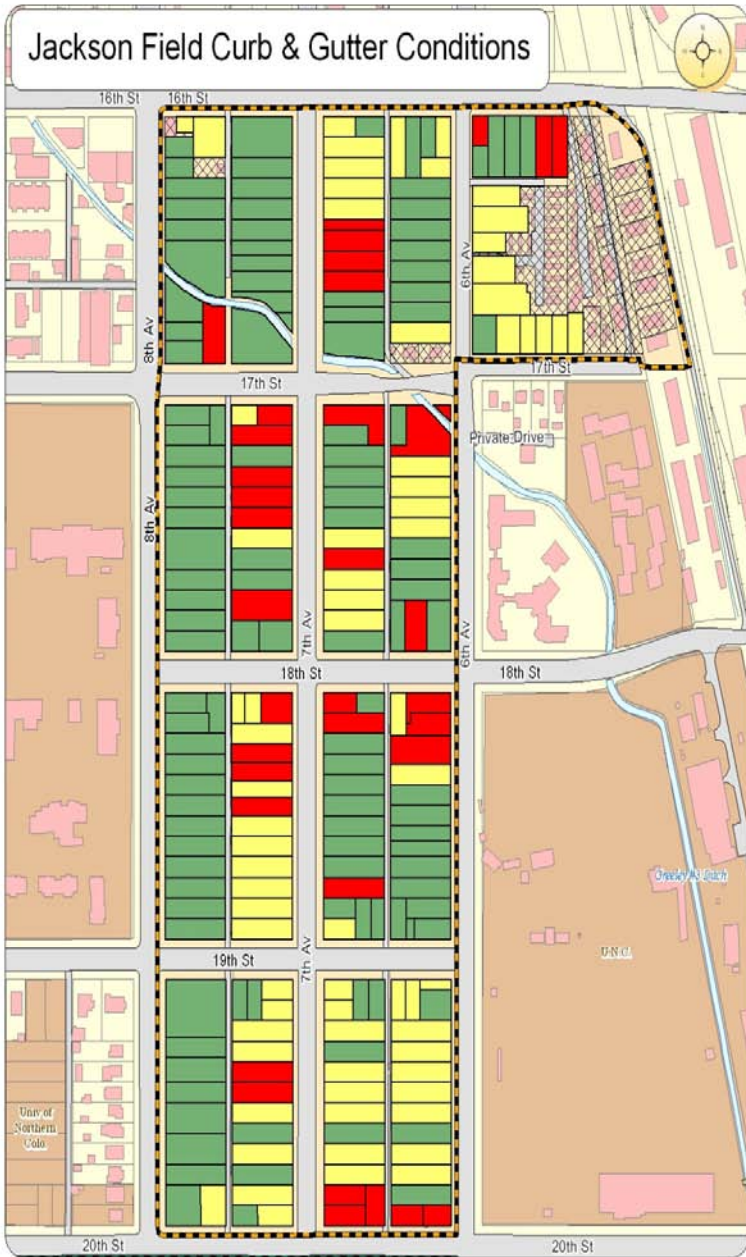
The overall condition of the curbs & gutters is fair, with areas with significant depreciation.

<u>Curb &amp; Gutter</u>	<u>Cost/Foot</u>	<u>Total Cost</u>
328' Missing	\$20.00	\$6,560
3,115' Inadequate	\$20.00	<u>\$62,300</u>
		\$68,860

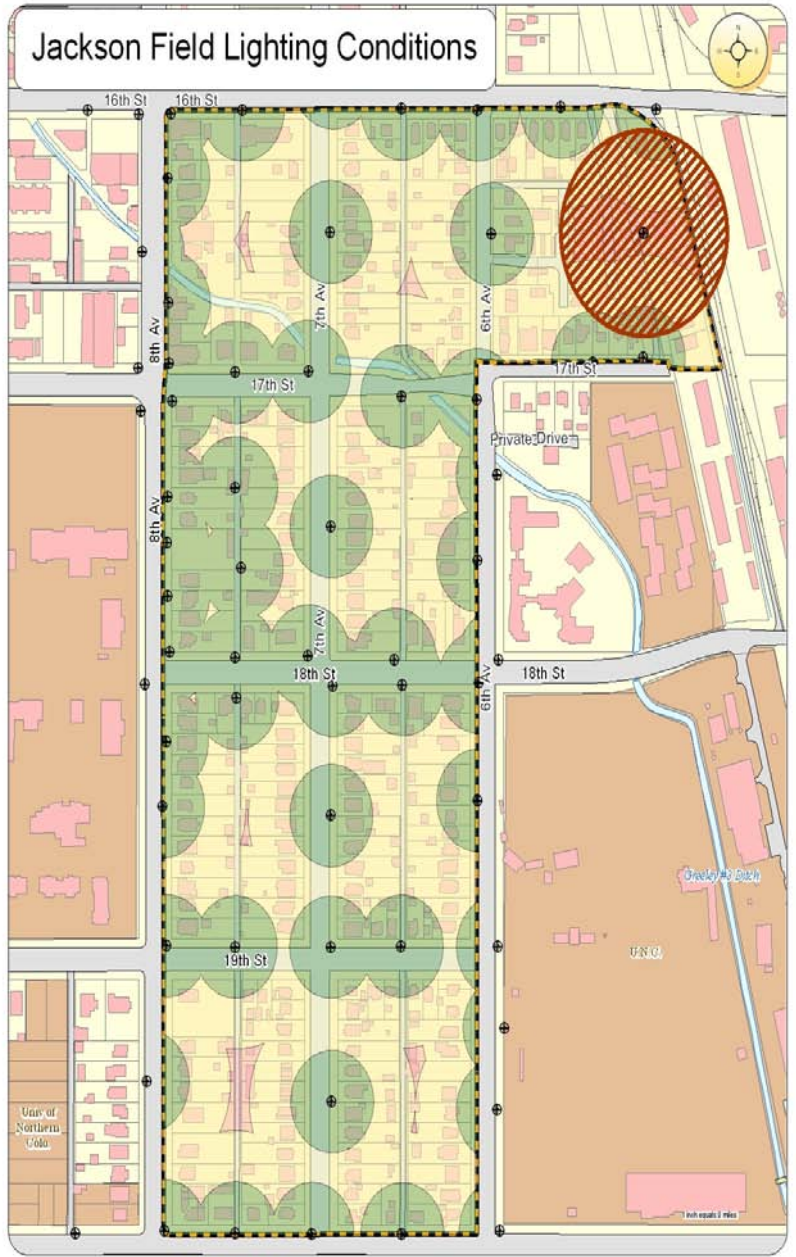
Street light coverage in the Jackson Field Neighborhood is adequate with lights at every intersection and mid-block. The lighting condition has been identified and mapped on the following page.

<u>Proposed Street Lights</u>	<u>Cost/Pole</u>	<u>Net Cost</u>
1	\$1,600	\$1,600
