# COLORADO CULTURAL RESOURCES INVENTORY

## Greeley 8th Avenue Survey

### Historical and Architectural Reconnaissance Form

4. Street Address: **720 14<sup>th</sup> Street**
5. Municipality: **Greeley, Colorado**
6. County: **Weld**
7. USGS Quad (7.5'): **Greeley, Colorado** year: **1950** **Photorevised 1980**
8. Parcel Number: **096108222001**
9. Parcel Information: Lot(s): **4** Block: **152** Addition: **Boomer's**
10. Acreage: **<1 (7500 square feet)**
11. PLSS information: Principal Meridian: **6th** Township: **5 North** Range: **65 West**  
**NE¼ NW¼ SE¼ NW¼** of section **8**
12. Location Coordinates: **Zone 13** **526273 mE** **4474045 mN**  
Datum: NAD83

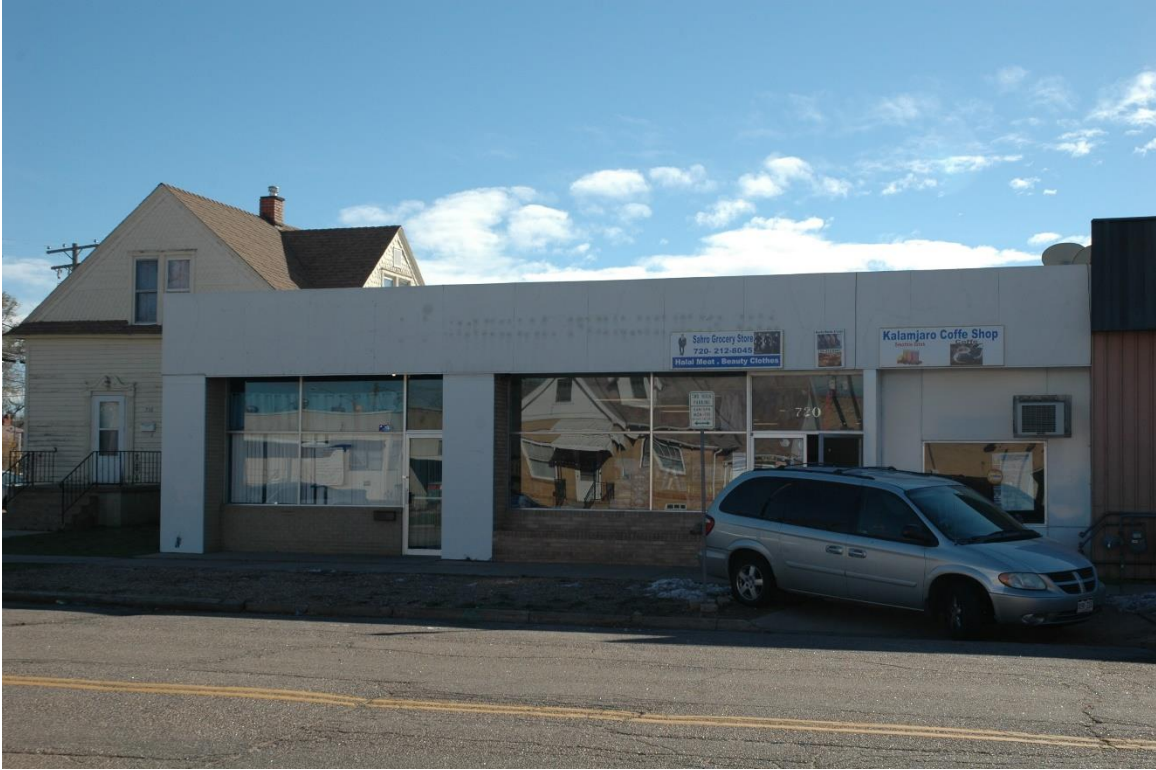
CD 2, Image 15, View to SSE of façade (north)

- Walls: **The north-facing (façade) wall is made of pale brown wire-cut brick laid in running bond. In the upper façade, the brick is covered by painted white stucco, while a brick column at the east end of the façade, and another brick column on the façade between the two storefronts, are both clad with a white metal veneer. A section at the far west end of the façade is also clad with a white metal veneer. The building's secondary walls are of concrete block construction.**

- Windows: **The north-facing (façade) wall contains two slightly recessed storefronts, both with expanses of fixed-pane windows with silver metal frames. The far west end of the façade (west of the two storefronts) contains a single-light fixed-pane window.**

- Roof: **The roof is flat with a flat parapet extending above the roofline on the façade.**
- Chimney(s): **N/A**
- Porch(s) / Doors: **The north-facing (façade) wall contains two slightly recessed storefronts, both with a glass-in-silver-metal-frame entry door with a transom light. These doors enter into the building's two retail spaces, currently occupied by Sahro Grocery Store, and Kalamjaro Coffee Shop.**
