# WHY SHOULDN'T I REPLACE MY WINDOWS?

- » [Architectural or Historical Significance](#)
- » [Physical Evaluation](#)
- » [Repair Class I: Routine Maintenance](#)
- » [Repair Class II: Stabilization](#)
- » [Repair Class III: Splices and Parts Replacement](#)
- » [Weatherization](#)
- » [Window Replacement](#)
- » [Conclusion](#)
- » [Additional Reading](#)

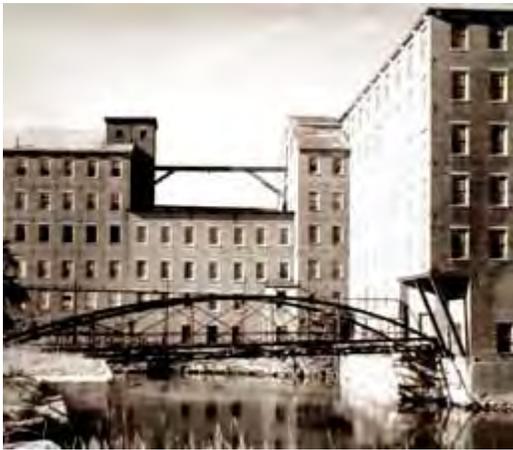
Windows are frequently important visual focal points, especially on simple facades such as this mill building. Replacement of the multi-pane windows with larger panes could dramatically alter the appearance of the building. Photo: NPS files.

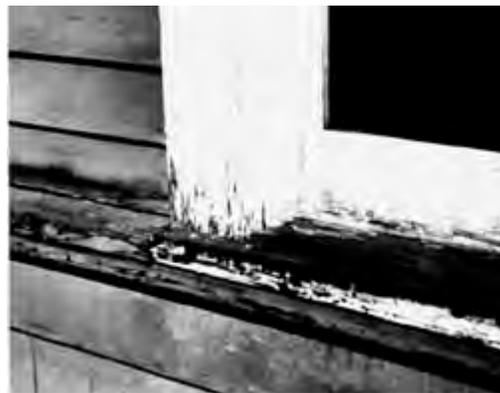
Deterioration of poorly maintained windows usually begins on horizontal surfaces and at joints, where water can collect and saturate the wood. Photo: NPS files.

Each window should be examined for operational soundness beginning with the lower portions of the frame and sash. Exterior rainwater and interior condensation can flow downward along the window, entering and collecting at points where the flow is blocked. The sill, joints between the sill and jamb, corners of the bottom rails and muntin joints are typical points where water collects and deterioration begins. The operation of the window (continuous opening and closing over the years and seasonal temperature changes) weakens the joints, causing movement and slight separation. This process

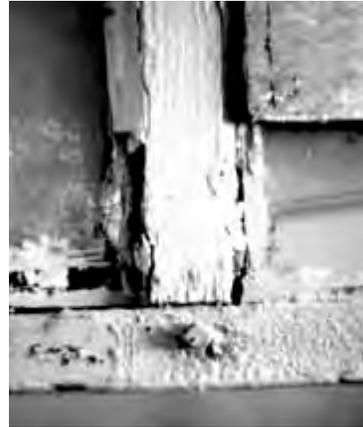
**This historic double-hung window has many layers of paint, some cracked and missing putty, slight separation at the joints, broken sash cords, and one cracked pane. Photo: NPS files.**

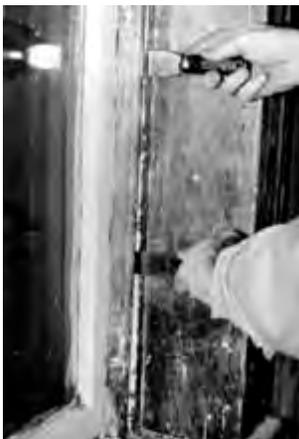
**After removing paint from the seam between the interior stop and the jamb, the stop can be pried out and gradually worked loose using a pair of putty knives as shown. Photo: NPS files.**

Paint removal should begin on the interior frames, being careful to remove the paint from the interior stop and the parting bead, particularly along the seam where these stops meet the jamb. This can be accomplished by running a utility knife along the length of the seam, breaking the paint bond. It will then be much easier to remove the stop, the parting bead and the sash. The interior stop may be initially loosened from the sash side to avoid visible scarring of the wood and then gradually pried loose using a pair of putty knives, working up and down the stop in small increments. With the stop removed, the lower or interior sash may be withdrawn. The sash

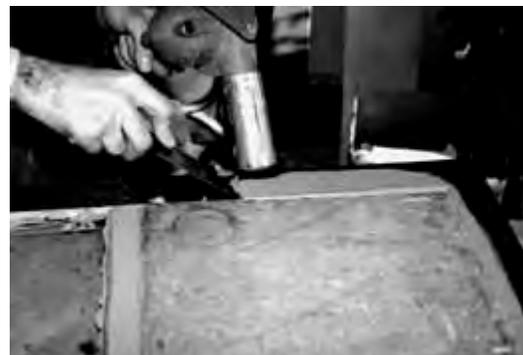
**Sash can be removed and repaired in a convenient work area. Paint is being removed from this sash with a hot air gun. Photo: NPS files.**

The sash can be stripped of paint using appropriate techniques, but if any heat treatment is used, the glass should be removed or protected from the sudden temperature change which can cause breakage. An overlay of aluminum foil on gypsum board or asbestos can protect the glass from such rapid temperature change. It is important to protect the glass because it may be historic and often adds character to the window. Deteriorated putty should be removed manually, taking care not to damage the wood along the rabbet. If the glass is to be removed, the glazing points which hold the glass in place can be extracted and the panes numbered and removed for cleaning and reuse in the same openings. With the glass panes out, the remaining putty can be removed and the sash can be sanded, patched, and primed with a preservative primer. Hardened putty in the rabbets may be softened by heating with a soldering iron at the point of removal. Putty remaining on the glass may be softened by soaking the panes in linseed oil, and then removed with less risk of breaking the glass. Before reinstalling the glass, a bead of glazing compound or linseed oil putty should be laid around the rabbet to cushion and seal the glass. Glazing compound should only be used on wood which has been brushed with linseed oil and primed with an oil based primer or paint. The pane is then pressed into place and the glazing points are pushed into the wood around the perimeter of the pane.

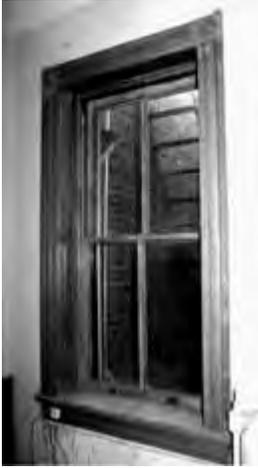
Following the relatively simple repairs, the window is weathertight, like new in appearance, and serviceable for many years to come. Photo: NPS files.

The operations just discussed summarize the efforts necessary to restore a window with minor deterioration to "like new" condition. The techniques can be applied by an unskilled person with minimal training and experience. To demonstrate the practicality of this approach, and photograph it, a Technical Preservation Services staff member repaired a wooden double-hung, two over two window which had been in service over ninety years. The wood was structurally sound but the window had one broken pane, many layers of paint, broken sash cords and inadequate, worn-out weatherstripping. The staff member found that the frame could be stripped of paint and the sash removed quite easily. Paint, putty and glass removal required about one hour for each sash, and the reglazing of both sash was accomplished in about one hour. Weatherstripping of the sash and frame, replacement of the sash cords and reinstallation of the sash, parting bead, and stop required an hour and a half. These times refer only to individual operations; the entire process took several days due to the drying and curing times for putty, primer, and paint, however, work on other window units could have been in progress during these lag times.

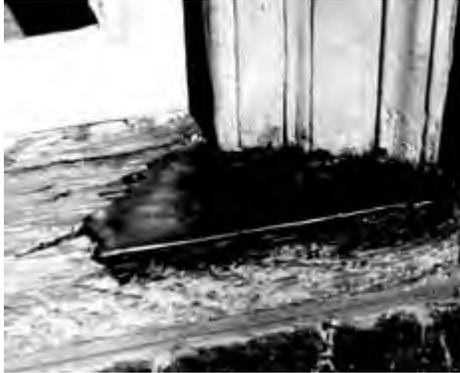
**This illustrates a two-part epoxy patching compound used to fill the surface of a weathered sill and rebuild the missing edge. When the epoxy cures, it can be sanded smooth and painted to achieve a durable and waterproof repair. Photo: NPS files.**

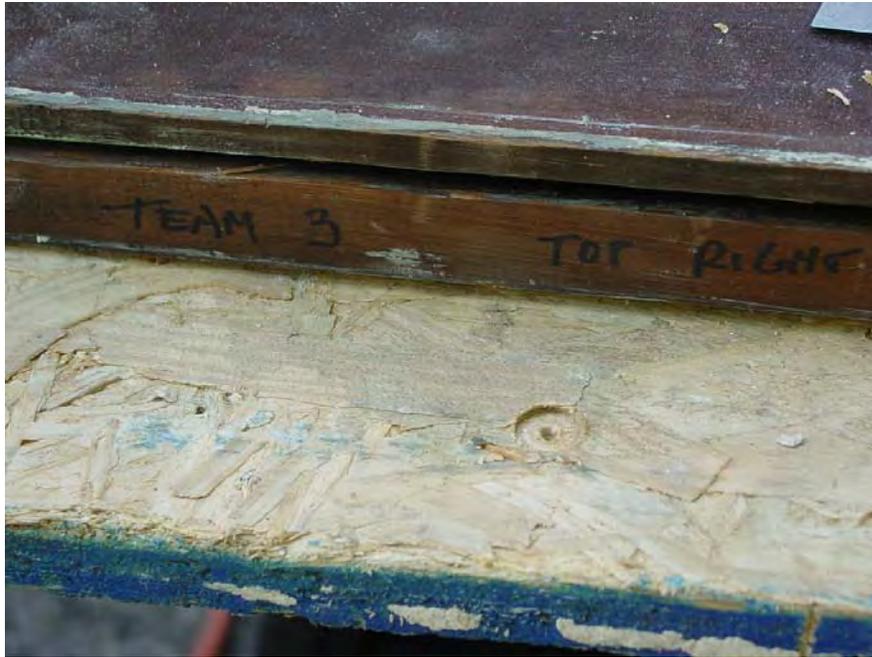
*Mark the unpainted sides of the sash side stiles*

1. Check the sashes while still in place and completely shut for side to side play in the jamb opening. This can vary between 1/8" and 3/8" on well maintained windows. Check play in sashes from top to bottom. In order for the meeting rails to meet properly in the middle there needs to be no more than 1/4" and no less than 1/8" play, top to bottom, when both sashes are closed. If the side-to-side play exceeds 3/8" and the top to bottom play exceeds 1/4" the jamb may have come apart and you should repair this first or hire a carpenter to make the repairs.
2. Carefully remove the interior sash stops, parting beads and both window sashes from the opening and mark them for location with an ink pen on the unpainted sides of each sash.

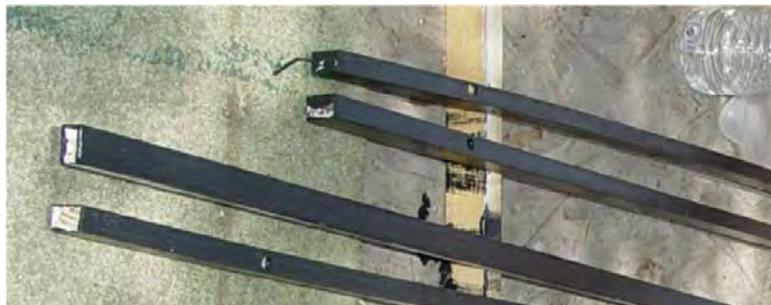
*New stock parting stop, primed, drilled and painted*

3. Make or buy at the lumberyard, new pine parting bead to match the dimensions of the original. Pre-prime/paint and countersink for a #6 screw of choice. The idea being that the parting stop is not nailed back in, as traditionally done, but screwed in so it can be easily removed for future maintenance of the sashes and jamb.

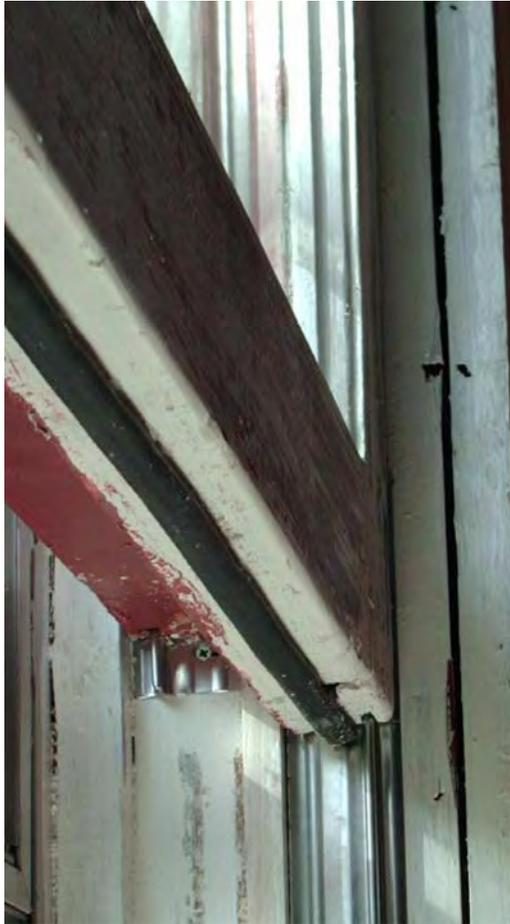
*Rubber installed in bottom of lower sash*

4. Leave all functioning sash pulleys in place. Remove non-functioning sash pulleys for repair or replacement with new or salvaged pulleys that match the originals.
5. Using a 5/32" slotting bit in a router, rout a groove on both sides of each sash 7/16" deep. The rib on the metal flange is 3/8" deep. The lower sash grooves are closer to the interior face of the lower sash and the slots on the upper sash are closer to the exterior face of the sash.

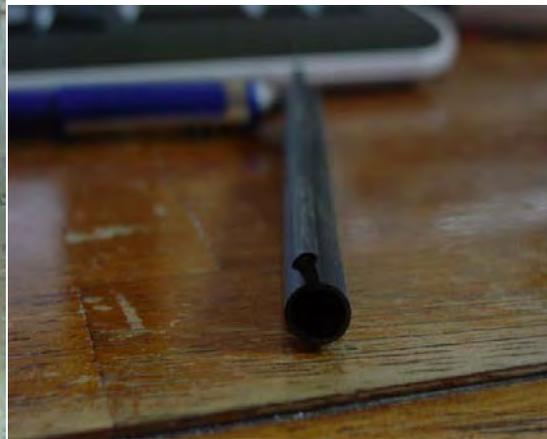
*"Santoprene" T-ribbed, rubber gasket*

6. Rout a narrow 3/32" slot in the check/meeting rail of the upper sash dead center. Also the bottom edge of the lower sashes bottom rail and the top edge of the upper sashes top rail. This is for your choice of rubber tube weather stripping. Be sure the rubber has a T-flange or barbed flange to friction fit in this narrow slot.

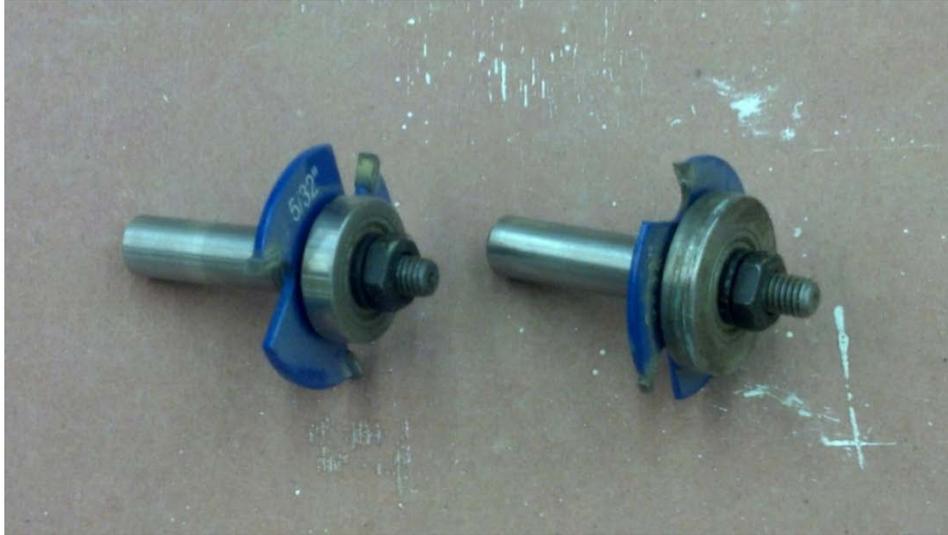
*5/32" slotting bit for track*

*3/32" slotting bit for rubber*

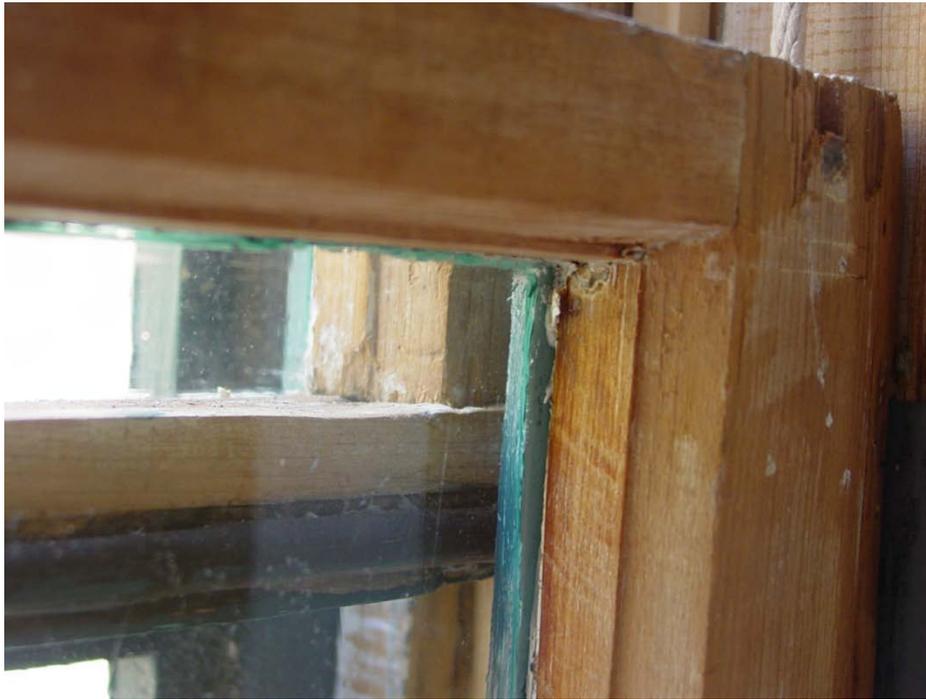
*Rubber installed in upper sash meeting rail*

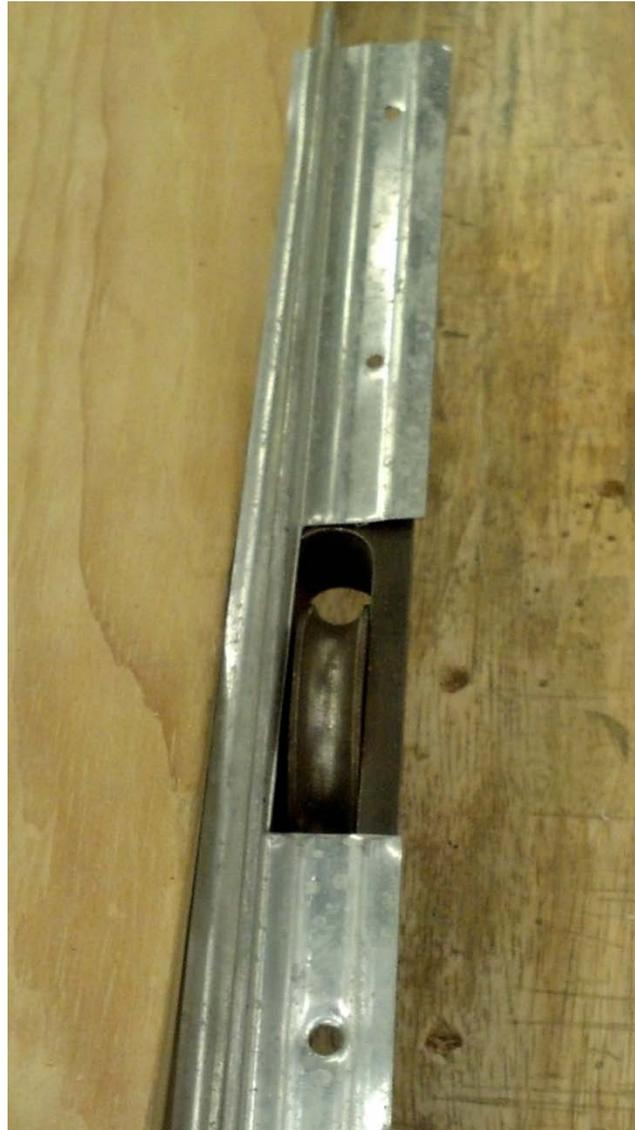
*Track cut out for pulley*

9. The two upper sash tracks will need to be cut out for the sash pulleys. Put the tracks in place and mark the track for the top and bottom of the pulleys. Using tin snips, cut the two marks all the way to the rib. Score several times against the rib between these two cuts with a sharp utility knife. Bend this cut metal several times back and forth until it breaks loose. Dress with a bastard file. Drill the upper tracks between the corrugations slightly smaller than the head of the #4 sheet metal screw that will attach the track to the side of the jamb for each sash. Drill one hole 1" from the top one 1/2" above the pulley, one 1/2" below the pulley, one dead center and one 1/4" from the bottom.

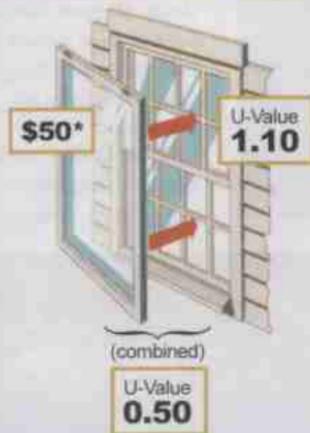
Storm window over single-pane original window

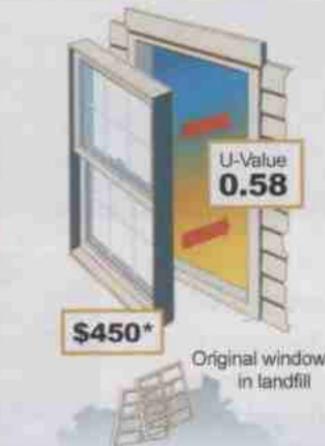
Double-pane thermal replacement of single-pane window

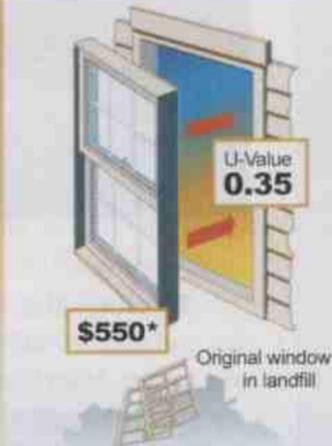
Low-e glass double-pane thermal replacement of single-pane window

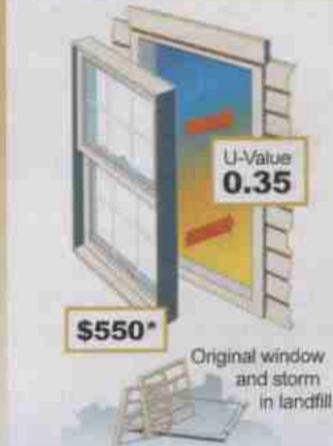
Low-e glass double-pane thermal replacement of single-pane window with storm window

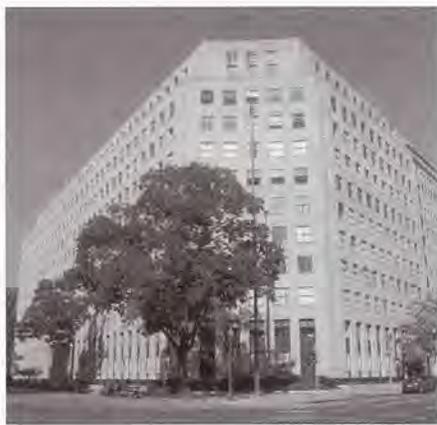
Fig. 1. Southwest elevation, Lafayette Building, Vermont Avenue and H Street NW, Washington, D.C. The building's neoclassical exterior has regularly placed, double-hung steel windows. All images by authors.

One structure currently being considered for such renovation is the Lafayette Building, a federal office building located in downtown Washington, D.C. (Fig. 1). Originally housing the Export-Import Bank of the United States and more recently the Department of Veteran Affairs, the Lafayette Building has had a long and storied history of federal

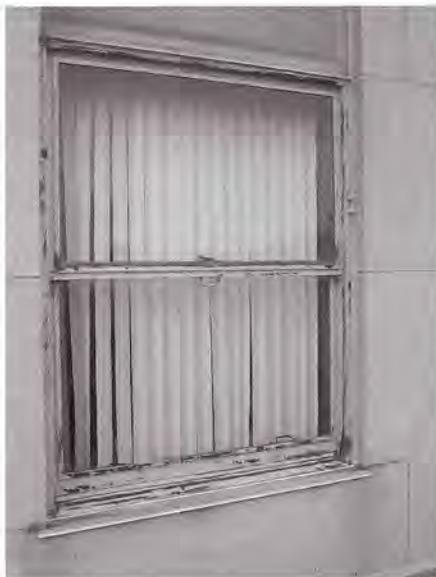
Fig. 2. View of an unrepaired steel-framed window on the east elevation of the Lafayette Building. Note the loss of paint coatings and corrosion of the built-up steel frame.

The building has nearly 1,200 windows along the primary facades and a single interior light court. The windows are constructed of steel shapes and were installed in a double-hung configuration (Fig. 2). The windows are approximately 54 inches wide and 72 inches high and have single glazing without intermediate muntins. Many of the windows exhibit paint flaking and some surface rusting, while others have more significant rusting, particularly at the base of the jambs (Fig. 3). The windows are currently operable and have counterweights in concealed weight pockets. This paper discusses a brief study comparing two options for treating the windows during the planned repair program.

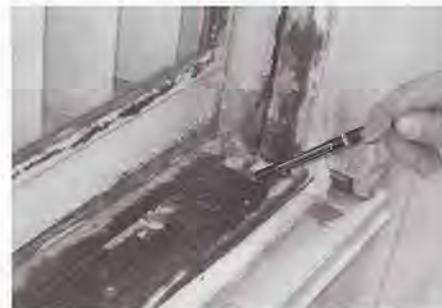
Fig. 3. View of a steel window sill on the east elevation of the eleventh floor. Note the significant corrosion of the steel frame at the sill-to-jamb corner.

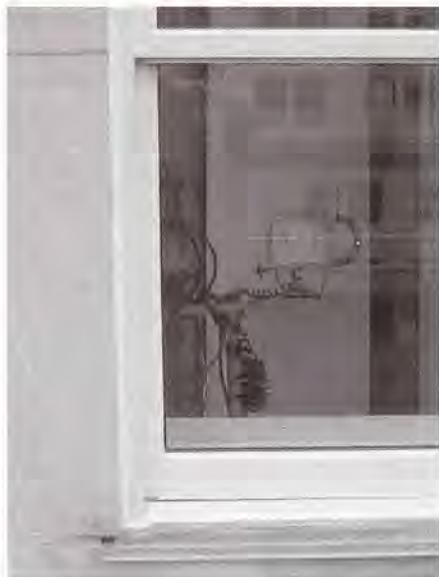
Fig. 4. Sill of the replacement window.

treatments proposed for the actual construction in order to provide accurate results for comparison (Figs. 4 through 7). Mock-ups were installed in the east elevation of the building at the eleventh-floor level based upon input from the owner and design team. The location on the east elevation of the eleventh floor, a height roughly equal with the rooftops of surrounding building, allowed a relatively unobstructed solar exposure and conditions that vary between the diffuse solar radiation of north exposures and the intense solar radiation of south and west exposures.

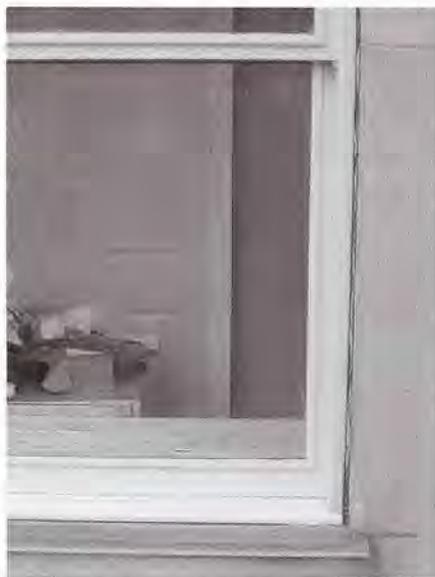
Fig. 5. Sill of the repaired window.

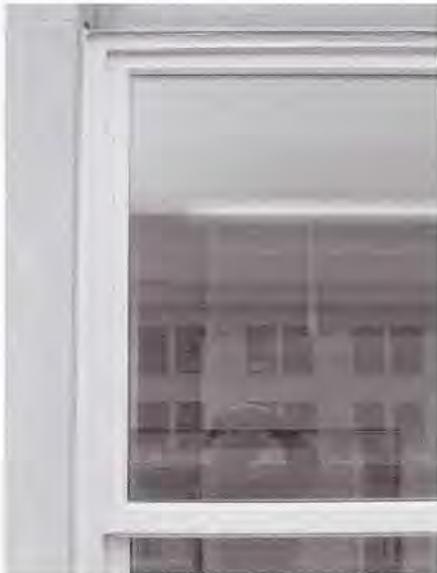
Fig. 6. Head of the replacement window.

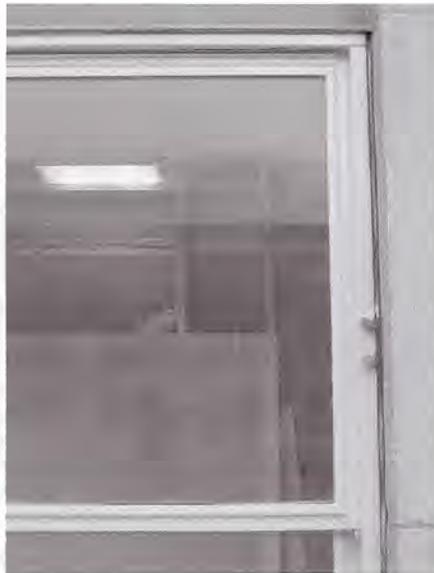
Fig. 7. Head of the repaired window. Note the similar sight lines but missing articulations and accessories of the replacement window when viewed in conjunction with the repaired window.

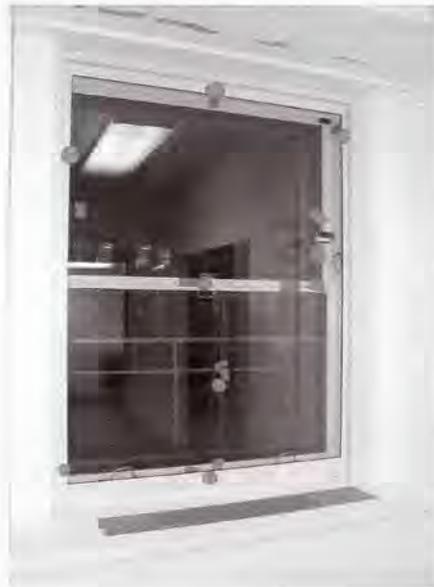
Fig. 8. Interior view of the repaired window prior to installation of the interior chamber. Note the thermal and relative-humidity sensors are indicated with dots. Some sensors are installed on the repaired window, and others are installed on the storm sash, resulting in more sensor locations than on the replacement window.

Both window mock-ups were instrumented with surface-temperature sensors (thermocouples) at critical frame and glass locations where maximum and minimum surface temperatures are expected to occur, such as at the center of the glass, the horizontal meeting rail, and perimeter frame locations. Relative-humidity and air-temperature sensors were also installed within the air cavity between the storm glazing and the exterior window to evaluate condensation potential within the storm cavity (Figs. 8 and 9). Ambient conditions were recorded on the building's exterior and interior, including the pressure differential between the interior and exterior conditions, using relative-humidity and temperature sensors and a digital pressure gauge. Data points for accessible locations were recorded on a laptop computer, while inaccessible data points (temperature and relative humidity within the storm of the rehabilitation window) were recorded on stand-alone data loggers.

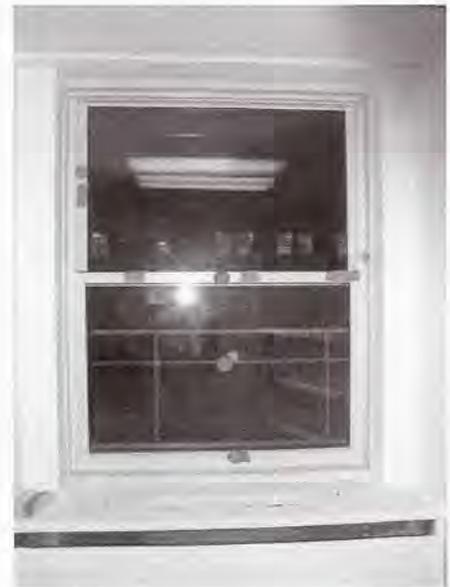
Fig. 9. View of the replacement-window mock-up prior to the installation of the interior chamber. The temperature sensors are indicated with dots.

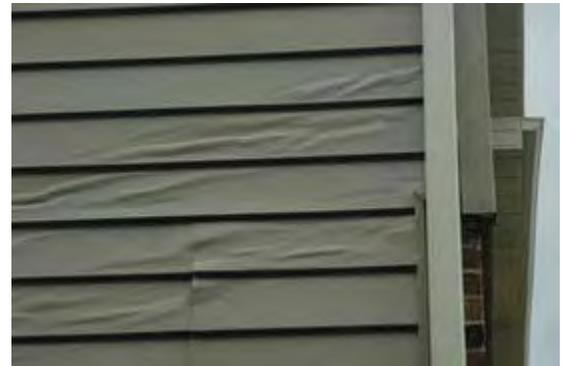
Image 1 of 3

**Tell-tale warping.** When vinyl siding is melted by sunlight reflecting off a window, the warped siding usually traces a diagonal path. This pattern follows the way the reflected sunlight moves across the wall as the sun travels across the sky. The photo shows melted siding on the home of Robb Kowalik, who lives in a suburb of Chicago.
